Performance of an instrumented stone column load trial at Kooragang Island, Newcastle, Australia

Stephen Jones
Douglas Partners Pty Ltd
Ernst Friedlaender
Keller Ground Engineering Pty Ltd

Keywords: Vibro-replacement, Stone Columns, Instrumentation, Monitoring

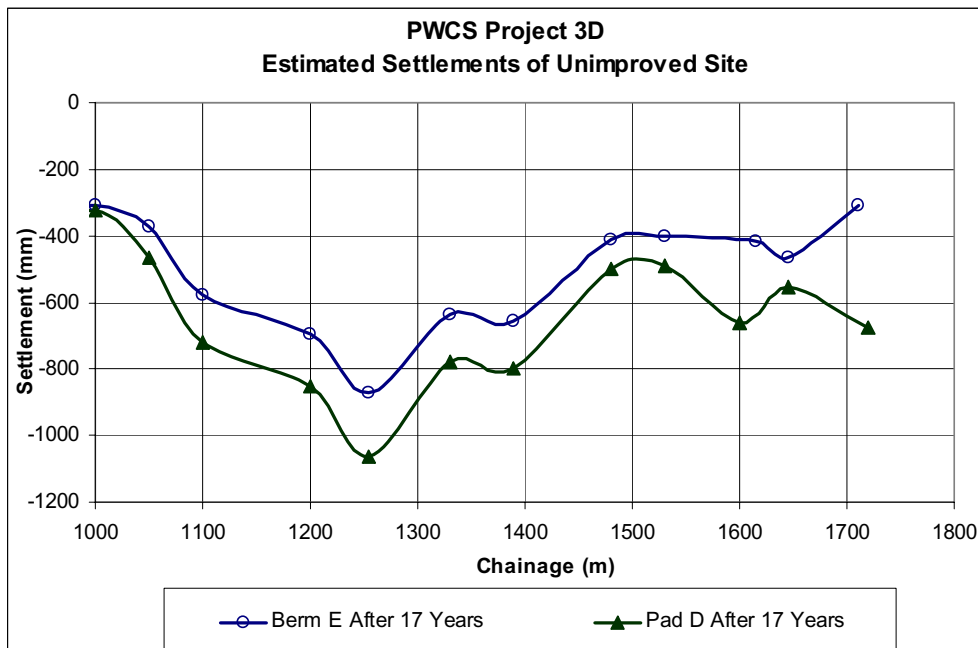
Figure 1: Estimated Settlement of Unimproved Site in the Area Requiring Ground Treatment

Without ground treatment there would be substantial settlements over time, as well as a high risk of shear failure upon initial application of the loads. The predicted settlements of the foundation, in the area of the trial pad, in the case of no ground treatment, are shown in Figure 1 below. These values include settlement of the deeper clay layers and creep.

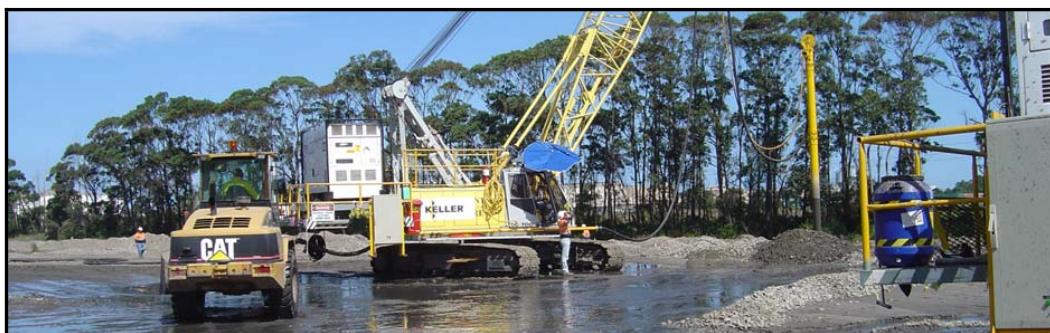
Figure 2: Installation of Stone Columns

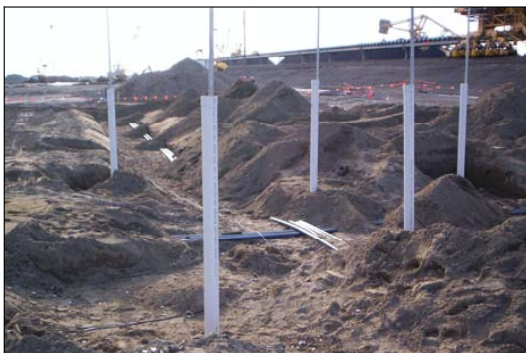
Figure 4: Instruments prior to placing fill

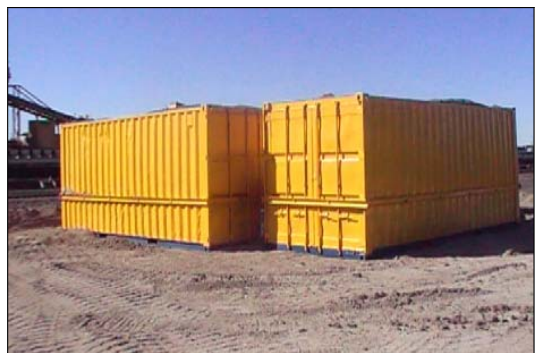
Figure 5: Containers on top of trial pad

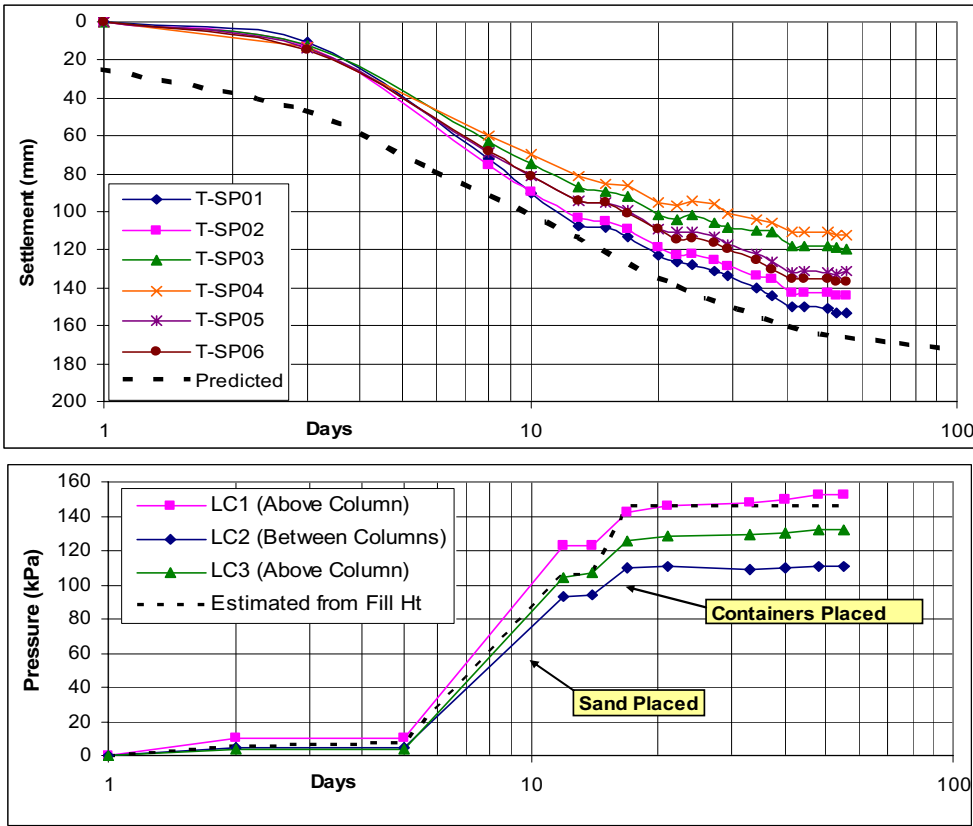
Figure 6: Settlement Plate Record and Load Cell Pressures

Primary consolidation was deemed to be substantially complete after about 40 days, which was consistent with the designer’s expectations. The settlement plates recorded total vertical movements in the range 112 mm to 153 mm, slightly less than predictions.

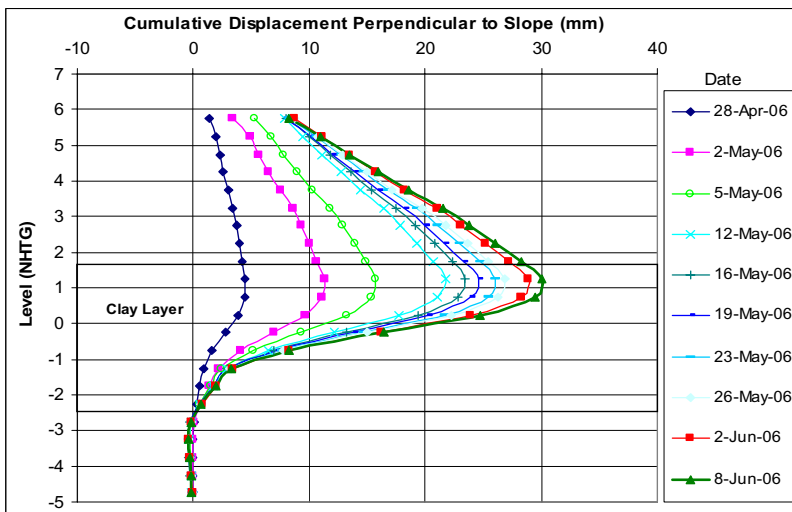
Figure 7: Plot of Inclinomometer No 3, which recorded the greatest lateral deformation

The lateral deflections in the clay layer were up to 30 mm beneath the toe of the fill batter (see Figure 7) and up to 8 mm beneath edge of the containers, which were close to the predictions of both consultants.

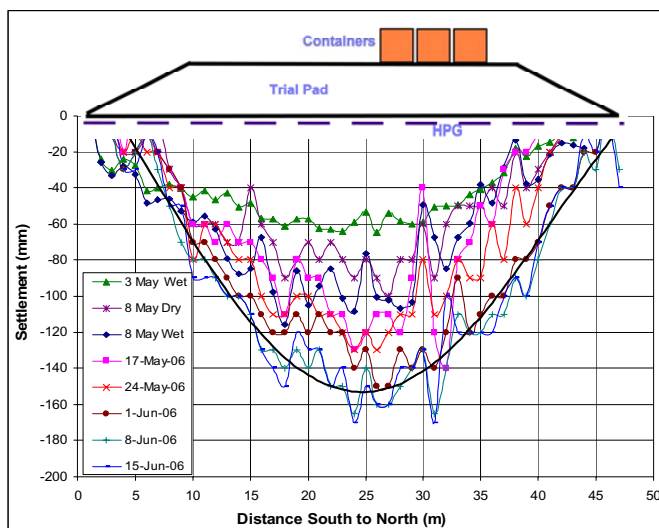
Figure 8: Hydrostatic Profile Gauge (North-South)

The HPGs recorded 160 ± 20 mm (see Figure 8) beneath the centre of the trial pad and exhibited a bowl-shaped deflection profile. The accuracy (repeatability) of the HPG's was disappointing, being poorer than the manufacturer's specification of ± 10 mm. Nevertheless, the overall magnitude and deflected shape was consistent with expectations.

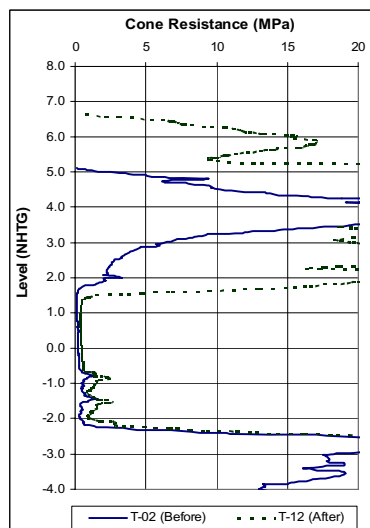
Figure 9: CPT before and after trial

The five cone penetration tests (CPT) carried out before stone column installation were repeated after the trial (in between columns), and revealed an increase in clay shear strength in the range 50% to 100%. This is a result of consolidation of the clay, as the soil takes a minor portion of the load, while the stone columns carry a major portion. The load cells implied that the columns attract up to 58% of the load, however the actual value is expected to be closer to 80%. Figure 9 shows the cone resistance plot from one of the before and after CPTs.
